# Manhole Inspection Summary

Manhole # S31KK\_009MH

Insp Date: **7/2/07 12:03 PM**

**Location** Address: **1901 FALLS RD**

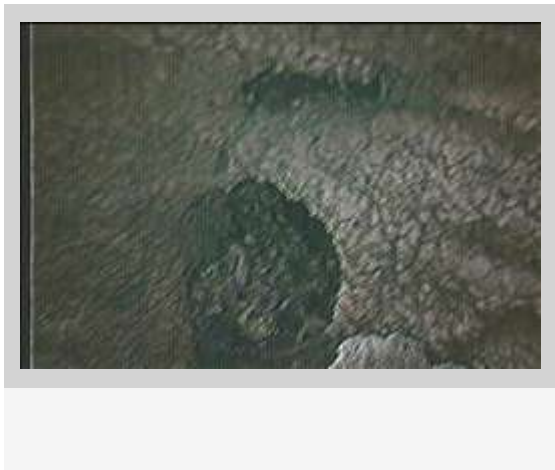
4 in. Circular Gravity Sewer  
Pipe In @ 4 O'Clock

Infiltration: **None** Pipe Seal Cond: **Unknown**
